Technical document

CVR examination

Date of occurrence:	January 25 th , 2010
Place of occurrence:	Off Beirut (Lebanon)
Aircraft type:	Boeing B737-800
Registration number:	ET-ANB
Operator:	Ethiopia (Ethiopian Airlines)
Flight Recorder:	Solid State Cockpit Voice Recorder (SSCVR) <ul style="list-style-type: none"> • Make and model: Allied Signal 6022 • P/N: 980-6022-001 • S/N: 05449

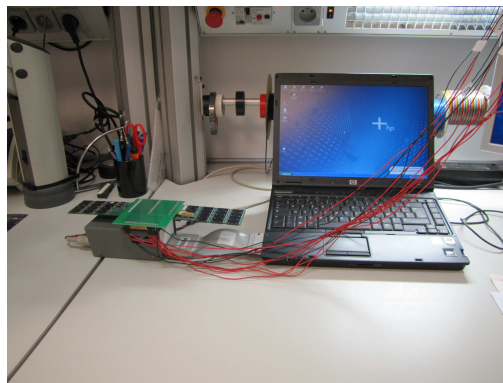
The CVR boards were connected to the BEA memory reader and each memory chip was individually selected and read out. All the memory chips were correctly read out except U16 (also referred as CE#19 memory chip in Honeywell documentation) which could not be read out at all. The read-out data was saved.

CVR boards connected to BEA memory reader

The assumption based on the visual inspection performed in February 17th, 2010 is confirmed: U16, the memory chip with the crack, is the non-functioning memory chip.

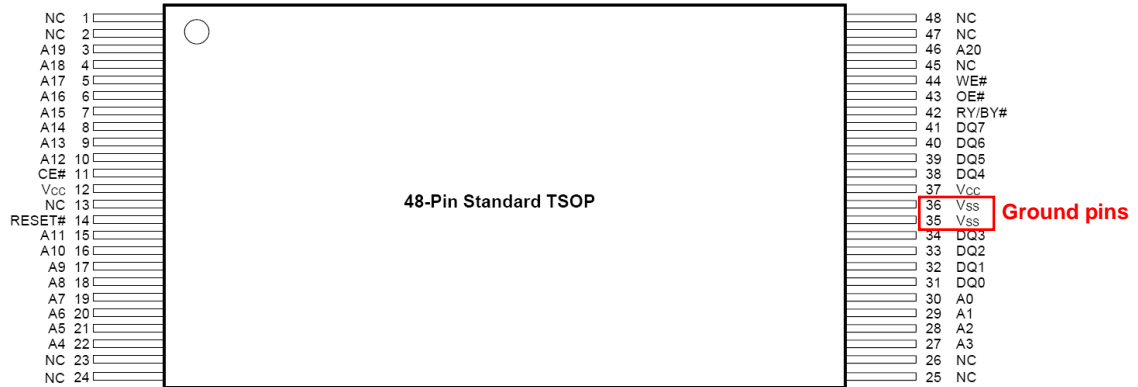
Connection diagram of U16 (AM29F016D)

All the pins located on the same side as the ground pins (Vss) show proper characterization. On the other side, the characterization of most of the pins, including CE pin used to activate the memory chip, was not the one expected.

Based on the external visual inspection and the asymmetrical results of the electrical characterization, it is very probable that the internal die is cracked and the data from U16 cannot be retrieved.
