Subject – Investigation of the Accident involving ET-409 on 25/01/2010

Air Safety Report

Occurrence O524-10

Event Title: GO AROUND DUE TO WEATHER AT BEY

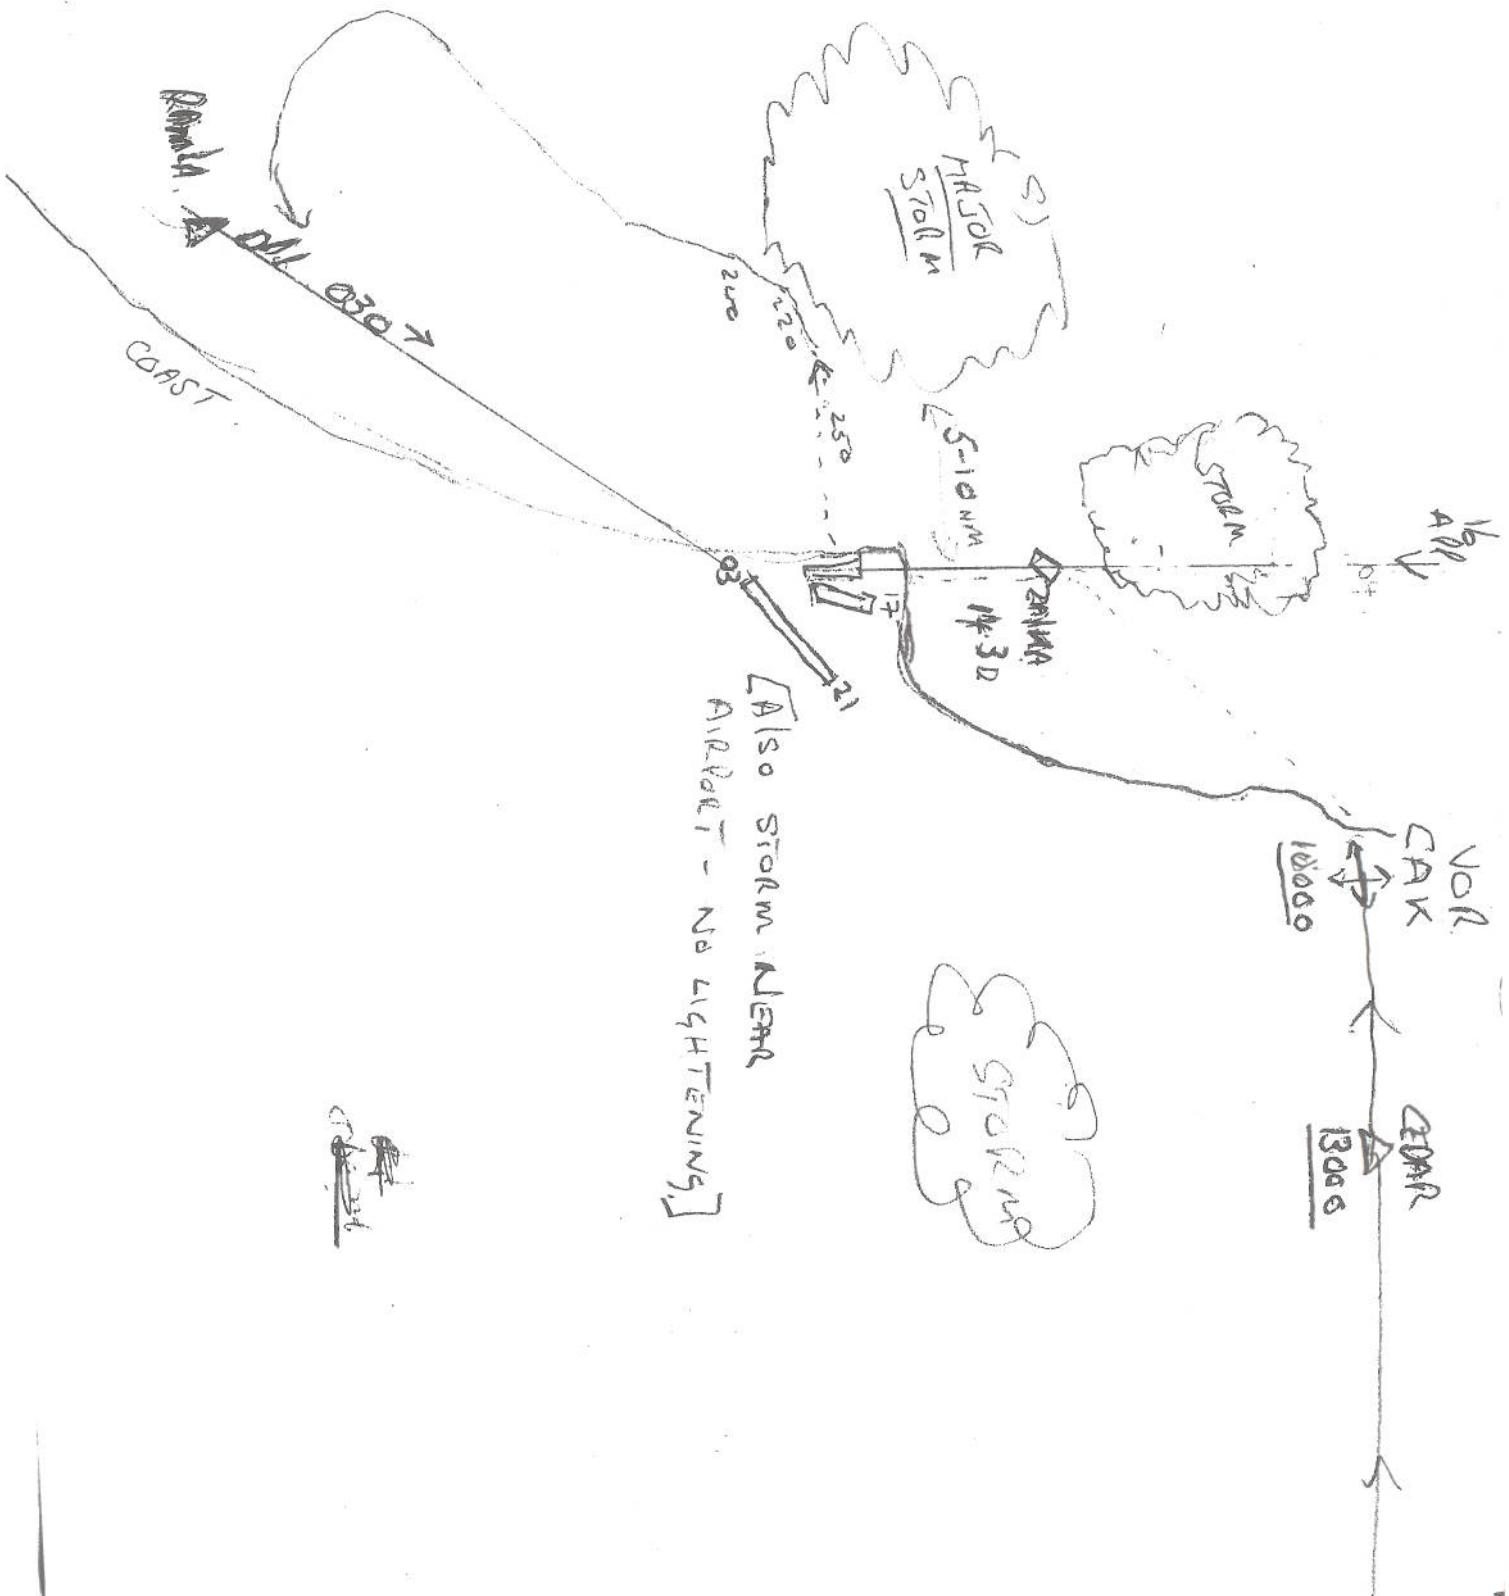
(Major Storm around 10 miles off coast and south east of earlier position.)

(A sketch of remembered storm positions for the approach is attached.)
